## Brazilian Journal of ANESTHESIOLOGY

### CASE REPORTS

# Oxygen delivery failure due to improper installation of carbon dioxide absorbent canister: a case report

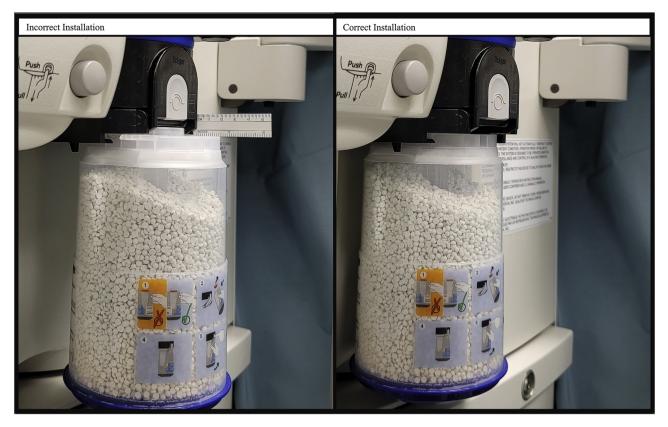
Figure 1 Installation of the carbon dioxide absorbent canister.

A 70-year-old man was brought to the operating room for repair of a right inguinal hernia. After induction of general anesthesia and placement of a laryngeal mask airway, manual ventilation with a reservoir bag in the anesthesia machine breathing circuit was not possible because of a lack of positive pressure. Oxygen (O<sub>2</sub>) desaturation occurred (from 100% to 62%) before a BVM connected to the auxiliary  $O_2$  source was used for ventilation. When the patient was successfully oxygenated and ventilated, the machine was inspected. On inspection, controlled mechanical ventilation with the ventilator provided positive pressure ventilation, but manual ventilation with the reservoir bag did not. It was then discovered that the CO<sub>2</sub> absorbent canister was not completely inserted. The canister was secured with the CLIC adapter system but was not fully seated in the absorbent canister bracket (Fig. 1), creating a large leak where the

top of the canister pressed on the spring-loaded rubber valve. An air leak could be felt near the canister. When the problem was identified, the canister was unclamped with a push of the CLIC adapter button, completely inserted into the bracket, and then secured by reengaging the adapter with a click. Correct installation of the CO<sub>2</sub> absorbent canister stopped the air leak (Fig. 1), and the case continued uneventfully. On further investigation, the pre-use automated machine checkout had been successfully completed without a  $CO_2$  absorbent canister in place. The  $CO_2$ absorbent canister was installed after checkout, and no additional leak test was performed after canister installation. At the end of the procedure, the laryngeal mask airway was removed, and the patient was awake and alert without any signs of complications approximately 20 minutes after arriving in the recovery room.

When the risk with the  $CO_2$  absorbent canister was identified, our anesthesiologists, nurse anesthetists, and anesthesia technicians were given education and reminders on proper installation of the canister. This case is a reminder of the importance of performing the additional manual pressure leak check of the machine immediately before the beginning of each procedure. It consists of setting the machine to spontaneous-manual ventilation mode, setting all gas at minimum flow, occluding the Y-piece of the breathing circuit, closing the adjustable pressure-limiting valve, and inflating the breathing bag with  $O_2$  from the  $O_2$  flush valve. A sustained pressure of 30 cm  $H_2O$  for more than 10 seconds confirms the integrity of the system.<sup>3</sup> A BVM must always be available and functioning in the operating room.<sup>4</sup>

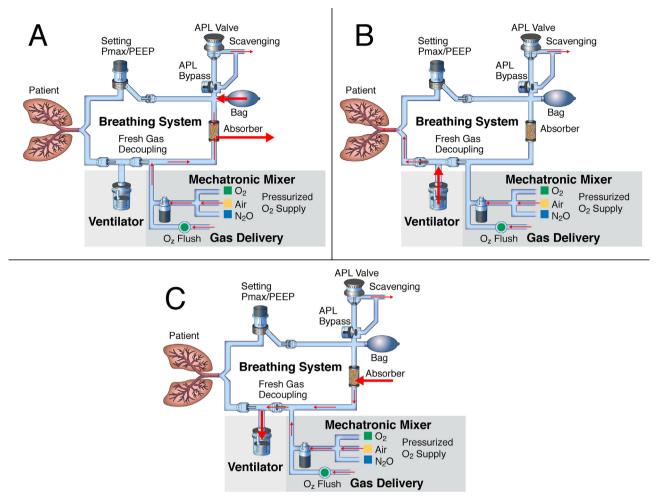
**Figure 2** Gas flow diagrams. A, Manual ventilation mode. B, In controlled ventilation during the inspiratory phase, the fresh gas decoupling valve closes and allows positive pressure ventilation to the lungs. C, In controlled ventilation during the expiratory phase, room air is drawn into the breathing circuit. Red arrow indicates the gas flow. APL indicates adjustable pressure-limiting;  $N_2O$ , nitrous oxide;  $O_2$ , oxygen; PEEP, positive end-expiratory pressure; Pmax, maximum expiratory pressure.

and causes a large gas leak where the machine connects to the  $CO_2$  absorbent canister. The result is minimal preoxygenation to the patient when the machine is in spontaneous ventilation mode, and manual positive pressure ventilation is not possible (Fig. 2A).

The location of the fresh gas decoupling valve in the Dräger Apollo design allows positive pressure ventilation to be provided if the machine is switched to controlled ventilation. The fresh gas decoupling valve excludes machine leaks between the ventilator and the exhalation valve, preventing retrograde gas flow through the CO<sub>2</sub> absorbent canister (Figs. 2B and 2C). However, concentrations of O<sub>2</sub> and inhalational agents will vary depending on the degree of gas leak. The leak may also cause volatile anesthetics to be in the working environment without being properly scavenged. Without a functioning CO<sub>2</sub> absorbent, the patient's end tidal CO<sub>2</sub> partial pressure may increase.
